# Evaluation of the post-fire erosion and flood control works in the area of Cassandra (Chalkidiki, North Greece)

Kastridis Aristeidis · Kamperidou Vasiliki

**Abstract** We quantified morphological and hydrographical characteristics of two drainage basins (Chanioti and N. Skioni) on Cassandra peninsula of Chalkidiki (North Greece), and evaluated the effectiveness of post-fire flood and erosion control works. The drainage basins were chosen because of their severe damage by fire, post-fire potential for erosion and flood due to the steep relief, and the importance of the area for residential and tourism development. The first measures taken in the area after the fire were salvage cutting of burned trees, a total ban on grazing, and construction of three types of works, log erosion barriers (LEBs), log check dams and contour branch barriers. Almost all necessary post-fire works were completed in both catchments but many construction failures were recorded. Approximately 75 % of the LEBs and 45 % of the contour branch barriers functioned properly, while the remainder failed. Nearly 80 % of the log dams were sedimented to 0–20 % of the dam height, 14.3 % were 20–40 % filled and 5.9 %

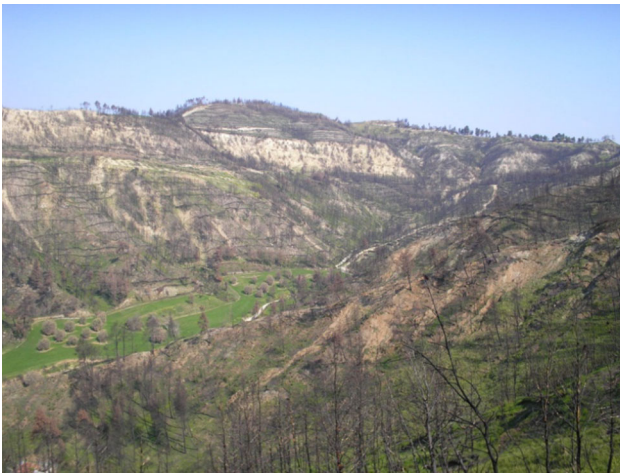
**Fig. 1** Part of burnt area of N. Skioni drainage basin

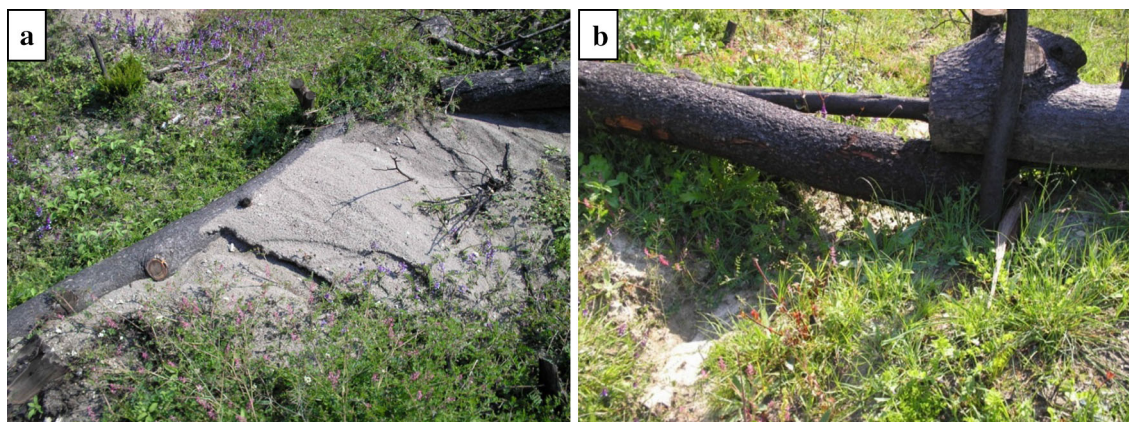
LEBs functioned better than contour branch barriers. Behind the logs, large amounts of small sediments accumulated and herbaceous plants colonized this material

(Fig. 5a), contributing to stabilization of the soil. Construction and placement failures of LEBs were also recorded. Crooked logs were placed without the necessary preliminary process of digging trenches to avoid gaps between the logs and soil (Fig. 5b). This failure enable water to flow beneath the log, causing soil erosion and sediment transport that was not controlled by the next downstream LEB line. Because of the erodible nature of the rocks and the steep relief of the area, logs used for LEBs should have been of diameters >20 cm to hold large quantities of sediment. In places with steeper slopes, more LEBs should have been constructed per unit of stream length. Approximately 75 % of LEBs were efficient at holding large amounts of sediment (Fig. 5a), while the remaining 25 % failed.

**Fig. 5** Representative examples of effective (a) and ineffective (b) LEBs in the study area

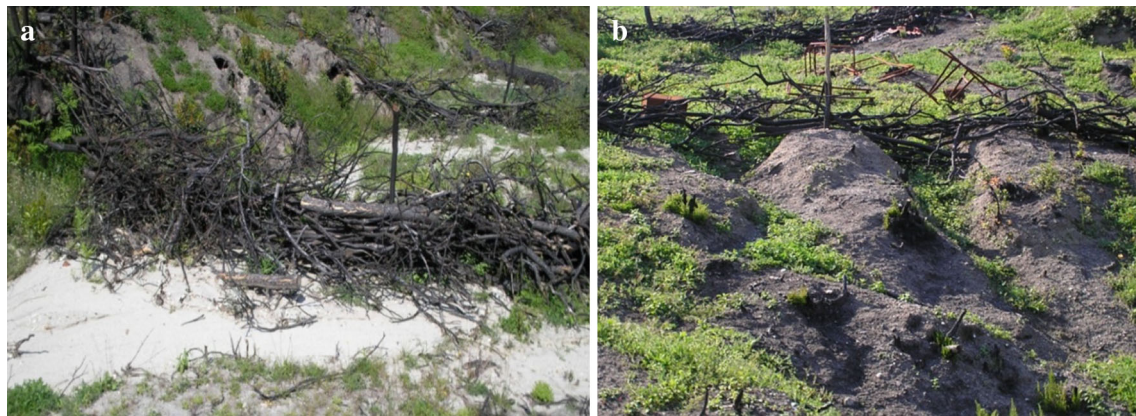
Sediments did not accumulate behind most of the branch barriers, indicating poor function. The branches were not tightly compacted and some branch barriers consisted only of a few branches (Fig. 6b). Furthermore, branch barriers were placed on the ground but not in trenches needed to stabilize the barriers and to ensure close contact between branches and the ground to block transfer of sediments. If all these factors had been taken into account, these works would have functioned more successfully. In places where contour branch barriers were constructed properly, they retained fine-grained sediments (Fig. 6a). Approximately 45 % of the contour branch barriers functioned properly and held fine-grained material, whereas the remaining 55 % were of low efficiency.

**Fig. 6** Representative examples of effective (a) and ineffective (b) contour branch barriers in the study area

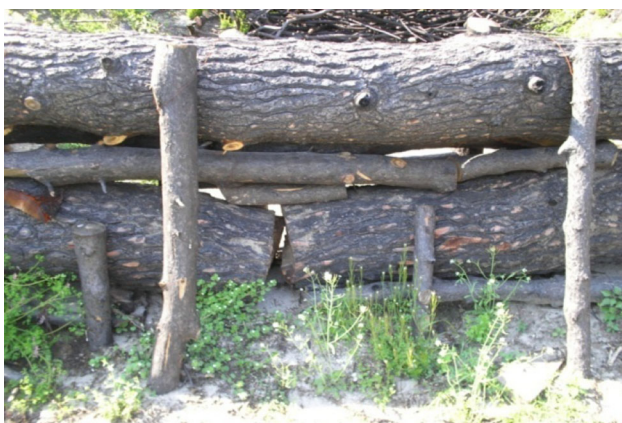
Failures were detected in the construction of log check-dams. The main causes of malfunctions were the improper placement of logs and the use of crooked logs, that created

gaps in the body of the dams (Fig. 7). As a result, only limited amounts of sediments accumulated behind the dams (Fig. 8a). Stabilization of the log dams was accomplished only using poles, without the construction of foundations at the sides or the bottoms of the log dams, increasing the risk of collapse of the dams (Fig. 8b) and undermining of the sides of dams.

**Fig. 7** Gaps between the logs of the log-dams and the resultant absence of sediments

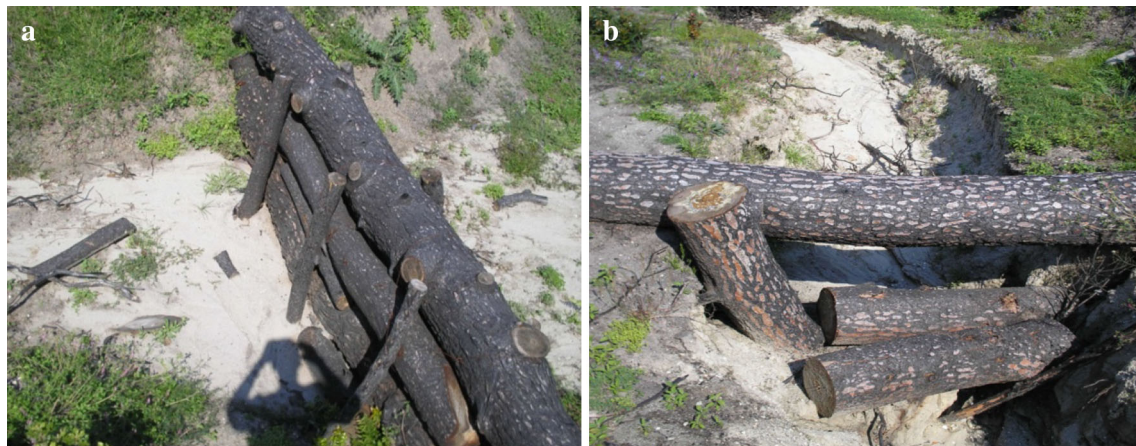
Spillways were not constructed at the crests of log dams for overflow of high-volume discharge. Thus there was no protection against side erosion by the streams. Also, there were no measures to prevent the undermining of the log dam foundations. Accumulation of sediments behind the log dams was limited, indicating that the dams were inefficient at holding materials that passed through the settlements and creating problems for the local population and their tourism infrastructure. Nearly 80 % of the log dams were filled with sediments to 0–20 % of the dam height, while 14.3 % of dams were filled to 20–40 % of the dam height and 5.9 % collapsed.

**Fig. 8** Representative examples of relatively effective (a) and ineffective (b) log check dams in the study area
