## Rock gabion, rock armoring, and culvert treatments contributing to and reducing erosion during post-fire flooding – Schultz Fire 2010

Daniel G. Neary<sup>a\*</sup>, Karen A. Koestner<sup>a</sup>, Ann Youberg<sup>b</sup>

This paper examines the effectiveness of gabion, armoring, and culvert treatments for erosion control after the Schultz Fire and discusses the reasons for failure or success. An objective is to also make recommendations for future use of these erosion control techniques.

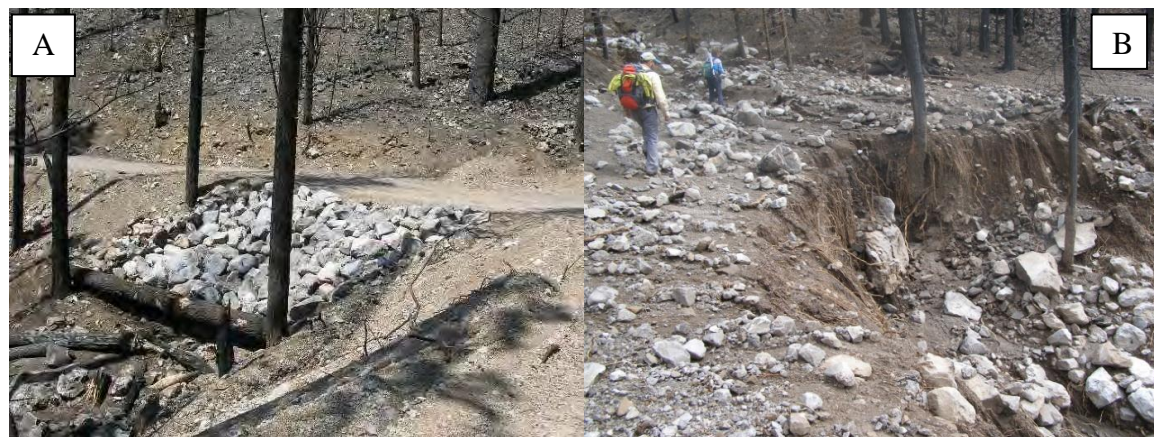
*Rock Armoring:* This treatment was done on the Waterline Road after the fire at 17 drainage crossings (Figure 1A). It consisted of placing 294 m<sup>3</sup> of large rocks (30-60 cm diameter) below the road on potential water flow paths. The downhill end of each rock armoring array was anchored to the ground by large logs.

*Rock Armoring:* The large rock armoring on the slopes below the upper elevation Waterline Road failed completely in the storm of July 20<sup>th</sup> (Figure 1B). All of it was washed away by the high water flows and deep gully incisions in that storm and subsequent storms. At most of the armored crossings, debris flows and runoff carrying much larger rocks than the armoring rocks (30 – 60 cm diameter) crossed the road and washed out the armored sections. The erosion control treatments were simply overwhelmed by the magnitude of the flood events. The size of the armoring pad rocks was too small to process high velocity flows coming off steep, 100%+ slopes. Flood flows lower on the mountain were powerful enough to knock over 13 Mg Jersey barriers. Larger rocks (1+ m in diameter) should have been used but there was probably not enough time to organize delivery of resources of that size. This erosion control technique contributed to the post-fire erosion and did nothing to reduce it. Therefore, this treatment is not recommended in steep terrain unless adequately sized rock material can be obtained.

**Figure 1.** Rock armoring along the Waterline Road before (A) and after (B) the July 20<sup>th</sup> flood.

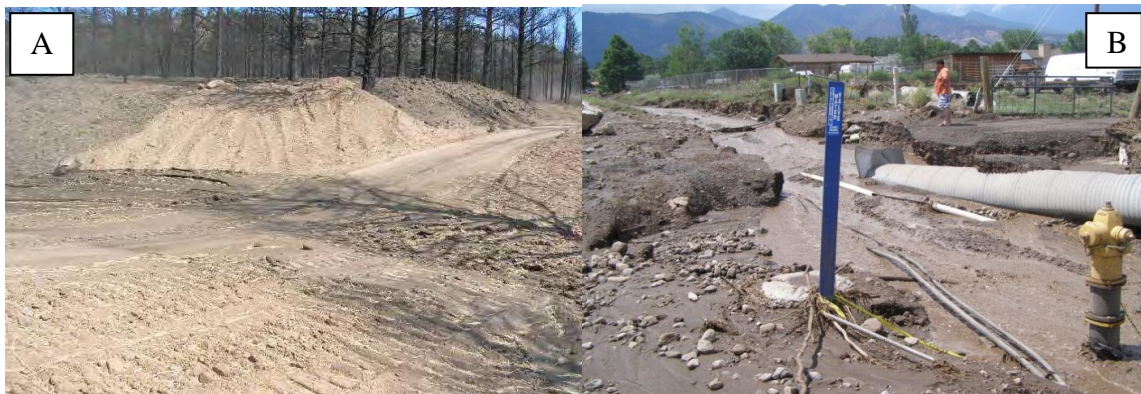
*Culvert Removal:* The low-water channel crossings on Forest Road 420 where culverts were removed functioned satisfactorily (Table 1) and prevented addition of road fill and fill-breach surges to the stormflow (Figure 2A). Some minor maintenance is required to keep the crossings trafficable after floods. Road culverts in the urban area were grossly under capacity and most were either buried, breached, or bypassed, increasing in the amount of sediment transported to lower elevations (Table 1, Figure 2B). In some instances, home owners replaced storm-damaged or poorly functioning culverts with larger diameter culverts only to have the same failure rate. Of the two that were successful in the private ownership area, one was designed as a concrete surfaced low-

water crossing. The other had a set of four 1-m wide culverts located in a depression that followed the gradient of the alluvial fan. This set of culverts was actually installed by Coconino County on a county road. The majority of the roads in the Timberline residential area are private, thus culvert sizing has not been standardized. Culvert removal on National Forest lands facilitated passage of flood flows from the upper slopes of the San Francisco Peaks. This treatment did not contribute to increased erosion and actually reduced potential erosion and flooding by eliminating the risk of road fill breaches. The culvert removal and low-water channel crossings treatment is recommended as a relatively inexpensive and effective means of coping with post-fire flood flows. Culverts on some private land would have performed better had been larger in diameter. However, others would have failed regardless of size due to excessive rock and woody debris. The best approach in most cases is culvert removal and construction of low-water crossings. Maintenance needs to be carried out on an as-needed basis after stormflow.

Ownership	Location	Treatment	# of Culverts	Failure Rate
National Forest	FR 420	Culvert Removal	30	0%
Private	Timberline	Left In Place	30	93%

**Figure 2.** An example of (A) successful culvert removal and construction of low-water crossings on National Forest lands; and (B) a bypassed and breached, undersized culvert on private property, Schultz Fire, Arizona.

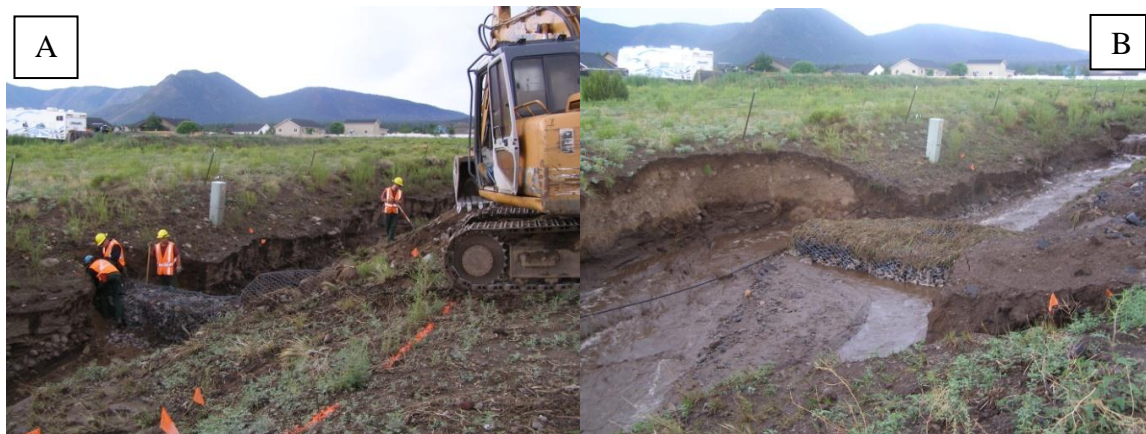
*Rock Gabions:* The gabions in the drainage ditch functioned for a short time but were then bypassed by flood flows, causing significant channel widening and transport of additional sediment (Figure 3). All of the gabions accumulated sediment on their upstream sides early in the storm event and then failed. Left side failures accounted for 56% (10). Only 11% (2) of the gabion failures occurred on the right side of the channel where the construction machinery was located (Figure 3A). An additional 33% (6) of the failures involved both sides of the gabion. The single factor contributing to the gabion failure was incomplete extension of the gabion wings into the left and right banks of the drainage ditch. The presence of phone, electricity, gas, water, and cable TV lines on both sides of the ditch restricted placement of the gabions.

**Figure 3.** Gabion construction along Campbell Avenue prior to the July 30, 2010, storm (A); and results during the storm event showing gabion failure and channel widening (B).

Figure 3B shows a phone line (black pipe downstream of a junction box) that was exposed by lateral widening of the Campbell ditch at a gabion. All the gabions had to be removed after the July 20<sup>th</sup> storm to reduce further channel widening and to make room for channel armoring with concrete. One section of the channel surface that was armored with concrete functioned successfully during the July 20<sup>th</sup> event. Gabion wire baskets can be used to reduce erosion from post-fire flood flows, but they need to be constructed correctly. Proper construction must include adequate gabion wing walls securely tied in 2-3 m beyond the channel slope breaks to prevent water from working around the wings. The center of the gabion should be at mid-channel and the lowest part of the structure. Channel flow velocities must also be considered. The Campbell Avenue channel has a slope of 4% so the average flow velocity was over  $1 \text{ m s}^{-1}$  with enough velocity to maintain hyperconcentrated streamflow. High flow velocities and the potential for structure failure were reasons why the Burned Area Emergency Response team (Robichaud et al. 2000) decided to not use channel structures like gabions above the Timberline area.
