## Measurement of post-fire hillslope erosion to evaluate and model rehabilitation treatment effectiveness and recovery

Peter R. Robichaud

Rocky Mountain Research Station, Forestry Science Laboratory, US Department of Agriculture, Forest Service, 1221 South Main Street, Moscow, ID 83843, USA. Telephone: +1 208 883 2349; fax: +1 208 883 2318; email: probichaud@fs.fed.us

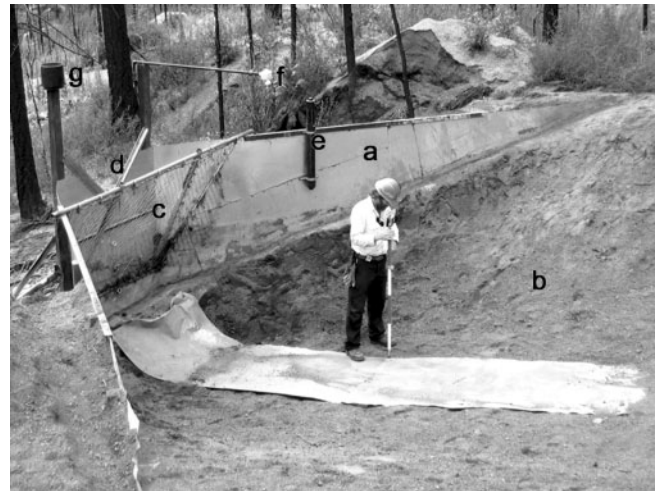
**Fig. 1.** Typical paired catchment sediment basin after removal of sediment. (a) Sheet metal barrier wall; (b) sediment basin area; (c) debris collection rack; (d) V-notch weir; (e) magnetic/electronic stage sensor; (f) ultrasonic depth sensor; and (g) tipping-bucket rain gauge.

Near the outlet of each catchment, a sediment impoundment structure is aligned within the main catchment channel and installed (Fig. 1). Each structure is adapted to fit the various contours of the individual catchments, but generally a sheet metal barrier with a V-notch weir is partially buried in a shallow (0.4–0.7 m) hand-dug trench and supported with wood posts and metal bracing. Concrete is poured into the trench on both sides of the sheet metal, embedding the base of the sheet metal wall to give it solid support and inhibiting undercutting by impounded water (Fig. 1). On the outside

of the sheet metal wall, concrete is poured into shallow pits where the angled metal supports enter the ground and below the V-notch weir to form a splash zone. Chain link fencing is attached inside the impoundment structure to form a ‘trash rack’ that protects the V-notch weir from large debris (Fig. 1) (Robichaud and Brown 2003).

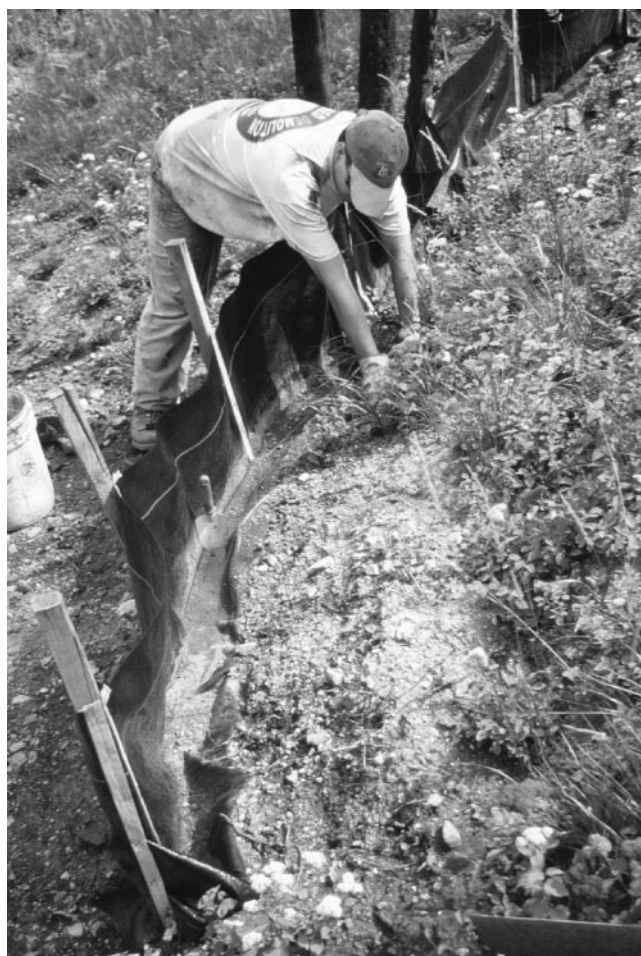
**Fig. 3.** Typical sediment fence where accumulated sediment is being removed.

Sediment fences, constructed of geotextile silt fence fabric, provide a less expensive method to directly measure hillslope erosion (Robichaud and Brown 2002) (Fig. 3). Using the installation procedure described in Robichaud and Brown

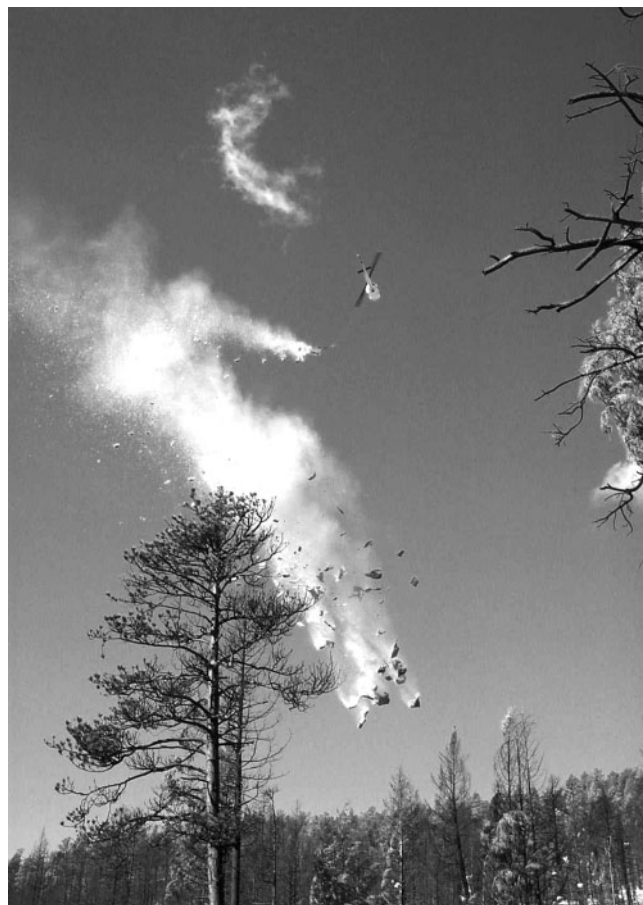
Fig. 4. Aerial application of straw mulch on a research catchment in the high-severity burned area of the 2002 Hayman Fire (Colorado, USA).

The use of helicopters to spread dry mulch is relatively new in post-fire emergency rehabilitation. Straw bales suspended in cargo nets break apart as they fall and spread further upon impact, resulting in a fairly even distribution of straw mulch with ~70% ground cover when applied at a rate of 2.4 Mg ha<sup>-1</sup> (Fig. 4). Owing to the cost and logistics of straw mulching, it is usually used to protect high-value resources, such as reservoirs, water quality, habitat, roads, structures and sensitive cultural sites, from upslope erosion.

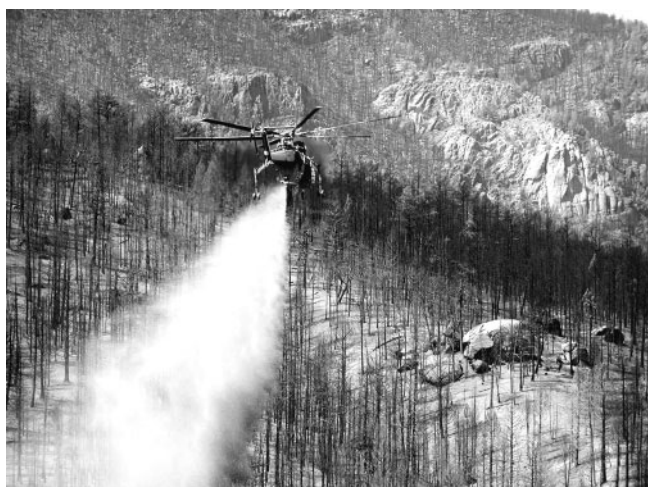
**Fig. 5.** Aerial application of hydromulch on a research catchment in the high-severity burned area of the 2002 Hayman Fire (Colorado, USA).

erosion by up to 97% in unburned applications (San Diego State University 2002). It has only been applied in a limited number of post-fire situations. For example, after the 2002 Hayman Fire in Colorado, 600 ha of aerial hydromulching was applied to steep, inaccessible areas that drain directly into the South Platte River and the reservoir system that provides 90% of Denver's municipal drinking water (Robichaud *et al.* 2003a). Large-scale application to burned hillslopes for post-fire rehabilitation requires helicopters fitted with slurry tanks and access to a nearby staging area, making aerial application of hydromulch more expensive than dry mulching treatments (Fig. 5).

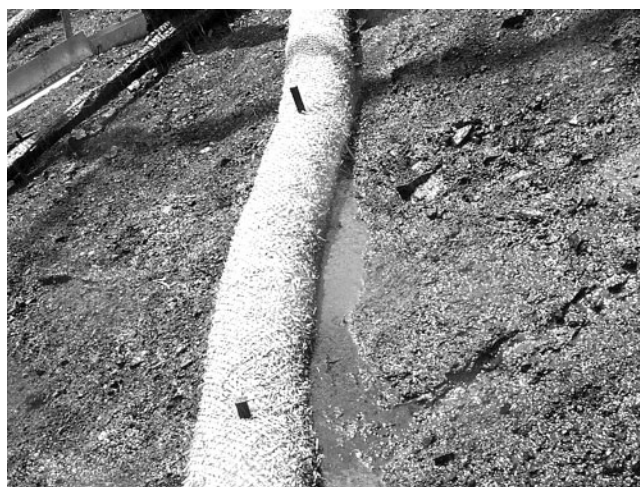
**Fig. 6.** A straw wattle erosion barrier is tested during a rainfall simulation experiment following the 2000 Valley Complex Fire (Montana, USA).

Straw wattles (Fig. 6), straw bales, LEBs (Fig. 7) and other natural and engineered structures have been used to provide mechanical barriers to overland flow, promote infiltration and trap sediment, and thereby reduce sediment movement on burned hillsides. LEBs have been used widely in areas where fires leave dead trees that can be felled, placed along the contours of burned hillslopes and staked in place, and the gaps between the logs and soil surface filled with additional soil to prevent underflow (Robichaud 2000b). Some recent installations have included the construction of soil berms at the end of the logs to increase their storage capacities.

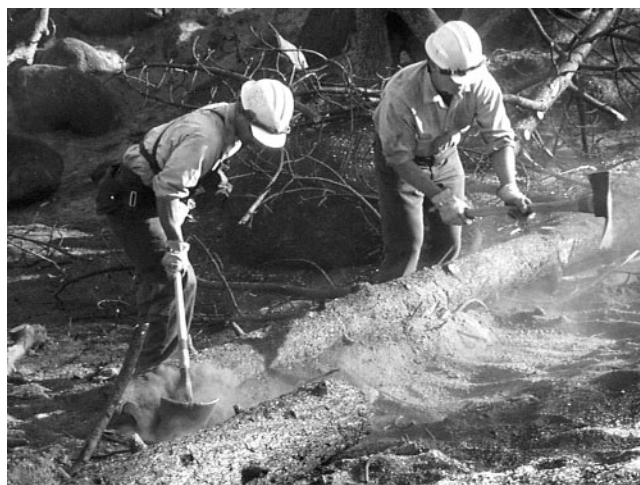
**Fig. 7.** Fire crews install a contour-felled log erosion barrier in a research catchment after the 1999 Mixing Fire (California, USA).
