# CONDITIONS FOR GENERATION OF FIRE-RELATED DEBRIS FLOWS, CAPULIN CANYON, NEW MEXICO

SUSAN H. CANNON<sup>1</sup>\* AND STEVEN L. RENEAU<sup>2</sup>

## ABSTRACT

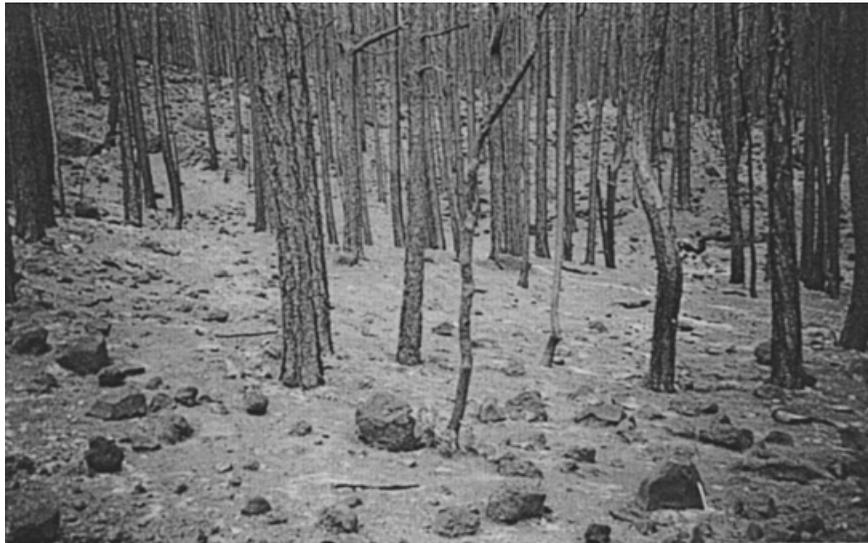
Figure 2. Photograph of hillslope in Capulin Canyon showing complete tree mortality and total consumption of tree needles and ground-covering vegetation and soil duff typical of high-intensity fire

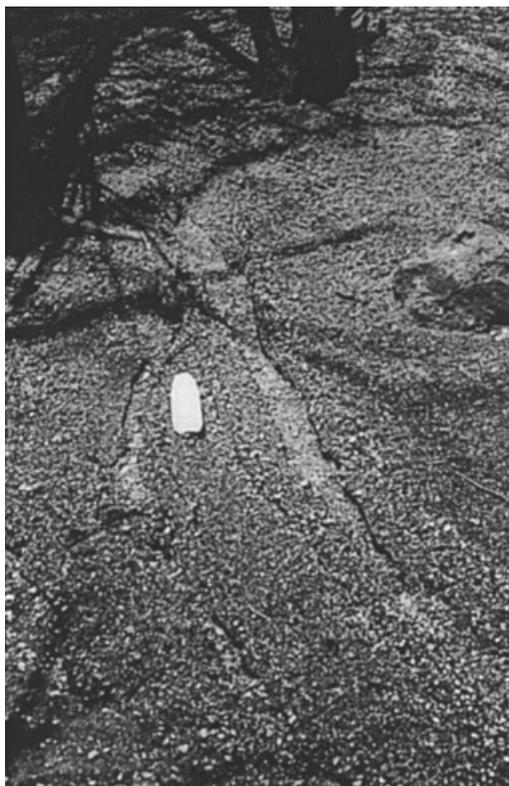
Figure 4. Photograph of rills developed on hillslope following 26 June 1996 rainstorm. Rills were up to 4 cm deep and 20 cm wide, with generally flat bottoms. Water bottle in centre of photograph is 20 cm long

on field observations, we conclude that the primary response of these hillslopes was considerable overland flow. Low-density pumice, ash, charcoal, pine needles and some burned mineral soil were rafted down the hillslopes and draws by this process. In some places rilling to depths of at most 4 cm and widths of 15 cm stripped the burned soil and ash from the hillslope (Figure 4). Rills started high on the hillslopes. Their frequency, depth and width were extremely variable, apparently depending on slope, materials and distance downslope. When surface water flow passed through an area mantled by abundant pine needles or by loose, gravel-sized pumice fragments, these materials could be incorporated, resulting in the formation of levees lining the rills (Figure 5). The levees were at most 50 cm wide and were composed primarily of pine needles, pumice gravel and charcoal fragments, with some fine-grained wood ash. Field textural characterization indicated the presence of very little silty matrix in the levees. The low-density pine needles and pumice gravel appear to have been rafted along the surface of the flows, rather than being incorporated into a single-phase slurry. The levee deposits may thus represent concentrations of floating materials that were pushed aside or stranded along the rills by more dilute flows. The passage of the surface water flows only cleared a path of loose, low-density materials, with no incision into the base. All observed paths left by these flows stopped at the change in slope at the base of hillsides.

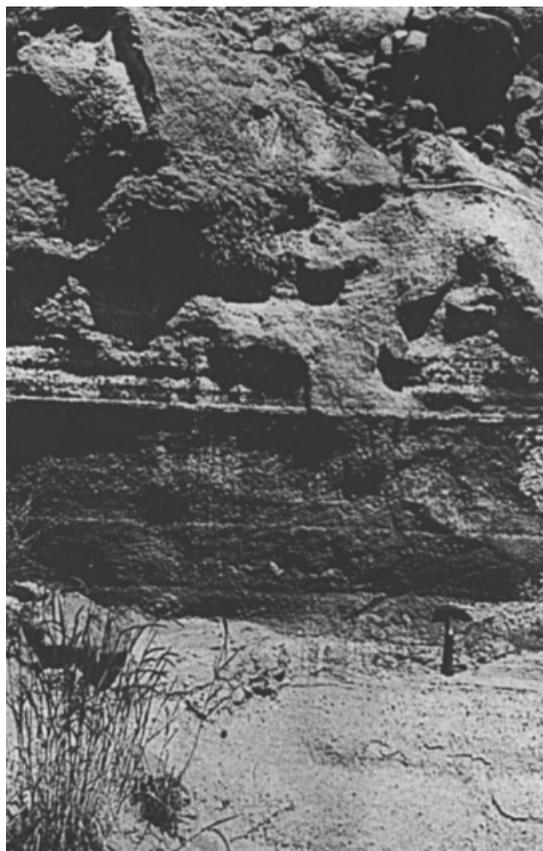
Figure 6. Photograph of dark brown debris-flow plaster generated during the 26 June 1996 storm deposited on light-coloured pumice outcrops in the North Tributary basin

In contrast with the Capulin Creek basin, the North Tributary basin produced at least one debris flow in the June 1996 storm, with discontinuous deposits observed both near the confluence of the tributary with Capulin Canyon and 400 m up the tributary. The deposit near the confluence consisted of a dark brown mud plaster on light-coloured pumice outcrops lining the channel (Figure 6). The plaster was not more than 1 cm thick and contained abundant charcoal fragments, indicating that material was contributed from the burned hillslopes. The upper mud line was approximately 2 m above the channel bottom and a mud splash line 1.5 m above the ground surface was observed on a tree on the right channel bank. The debris-flow plaster was not continuous,

as it had apparently been preferentially washed off smooth rock surfaces by subsequent floodwaters, either during the same event or later. The debris-flow deposits observed farther up the tributary were at most 70 cm thick, and consisted of material up to 60 cm in diameter in abundant dark brown, silty-sand matrix. A sample of this material can be classified as either a silty sand (SM) or a clayey sand (SC) using the Unified Soil Classification (Craig, 1987); plasticity characteristics are unknown. Abundant large voids, as well as pine needles, were observed within the deposits. The deposit surface was nearly flat and had been washed, either by recessional flow or later flood events, leaving a fine sand lag on the surface. No evidence of this debris-flow deposit could be found along Capulin Creek itself, presumably because of dilution or erosion by the high floodwaters.
