Paper Number: 068009

Protection from Erosion Following Wildfire

**Written for presentation at the
2006 ASABE Annual International Meeting
Sponsored by ASABE
Portland Convention Center
Portland, Oregon
9 - 12 July 2006**

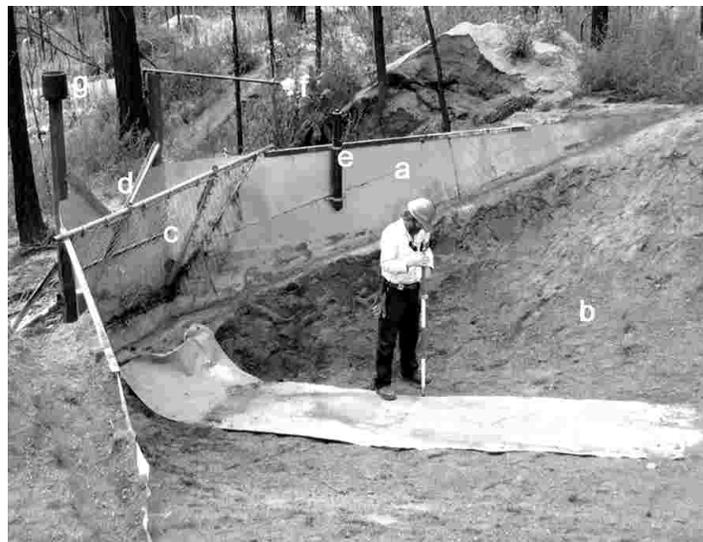
Figure 1. Typical paired catchment sediment basin after removal of sediment. a) sheet metal barrier wall; b) sediment basin area; c) debris collection rack; d) V-notch weir; e) magnetic/electronic stage sensor; f) ultrasonic depth sensor; g) tipping bucket rain gauge (Robichaud 2005).

Paired catchments—A paired catchment experiment measures runoff and sediment yield from natural rainfall in two adjacent catchments (2 to 10 ha with natural drainage to a single exit point) that are closely matched for size, slope, aspect, elevation, soil characteristics, and burn severity. One catchment has a postfire rehabilitation treatment applied and one is left untreated as a control. Runoff is measured using a 90 degree V-notch weir and sediment, which is collected in the impoundment basin, is removed, weighed, and sampled manually after each rain event. Rainfall intensity, amount, and duration are related to the measured runoff and sediment yield (fig. 1).

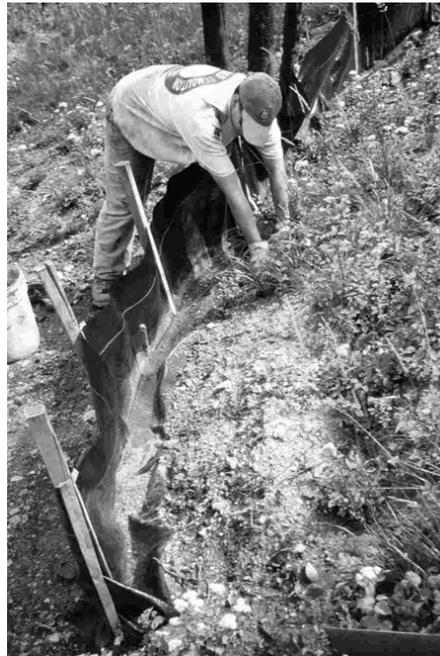
Figure 2. Typical sediment fence where accumulated sediment is being removed (Robichaud 2005).

Sediment fences—Sediment fences, constructed of silt fence fabric, provide a less expensive method to directly measure hillslope erosion (Robichaud and Brown 2002). Although runoff cannot be assessed, multiple fences allow for several replicates of each treatment. Sediment fences are best located on uniform slopes with minimal obstructions or in small swales (less than 0.5 ha in size). As with paired catchments, collected sediment is removed, weighed, and sampled manually after each storm event, and data from continuous-recording tipping-bucket rain gauges allow rainfall intensity, amount, and duration to be related to sediment yields (fig. 2).

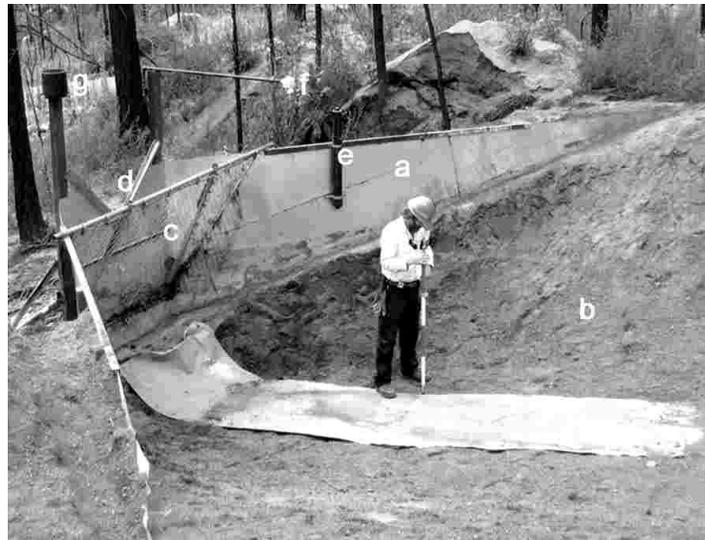
Figure 1. Typical paired catchment sediment basin after removal of sediment. a) sheet metal barrier wall; b) sediment basin area; c) debris collection rack; d) V-notch weir; e) magnetic/electronic stage sensor; f) ultrasonic depth sensor; g) tipping bucket rain gauge (Robichaud 2005).

Paired catchments—A paired catchment experiment measures runoff and sediment yield from natural rainfall in two adjacent catchments (2 to 10 ha with natural drainage to a single exit point) that are closely matched for size, slope, aspect, elevation, soil characteristics, and burn severity. One catchment has a postfire rehabilitation treatment applied and one is left untreated as a control. Runoff is measured using a 90 degree V-notch weir and sediment, which is collected in the impoundment basin, is removed, weighed, and sampled manually after each rain event. Rainfall intensity, amount, and duration are related to the measured runoff and sediment yield (fig. 1).

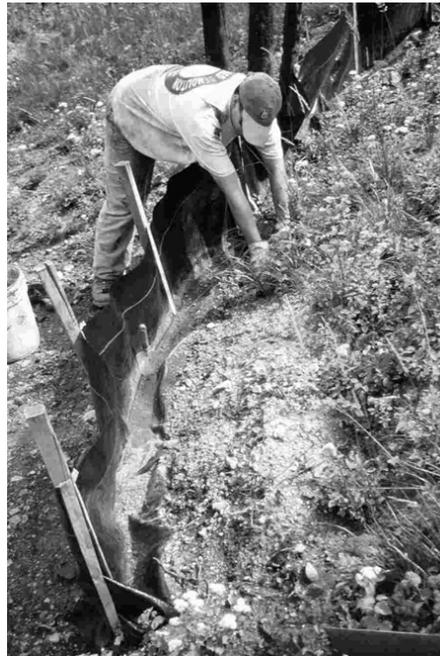
Figure 2. Typical sediment fence where accumulated sediment is being removed (Robichaud 2005).

Sediment fences—Sediment fences, constructed of silt fence fabric, provide a less expensive method to directly measure hillslope erosion (Robichaud and Brown 2002). Although runoff cannot be assessed, multiple fences allow for several replicates of each treatment. Sediment fences are best located on uniform slopes with minimal obstructions or in small swales (less than 0.5 ha in size). As with paired catchments, collected sediment is removed, weighed, and sampled manually after each storm event, and data from continuous-recording tipping-bucket rain gauges allow rainfall intensity, amount, and duration to be related to sediment yields (fig. 2).
