THE EFFECTIVENESS OF AERIAL HYDROMULCH AS A POST-FIRE EROSION CONTROL TREATMENT IN SOUTHERN CALIFORNIA

Peter M. Wohlgemuth, Hydrologist, USDA Forest Service, Riverside, CA, pwohlgemuth@fs.fed.us; Jan L. Beyers, Plant Ecologist, USDA Forest Service, Riverside, CA, jbeyers@fs.fed.us; Peter R. Robichaud, Research Engineer, USDA Forest Service, Moscow, ID, probichaud@fs.fed.us.

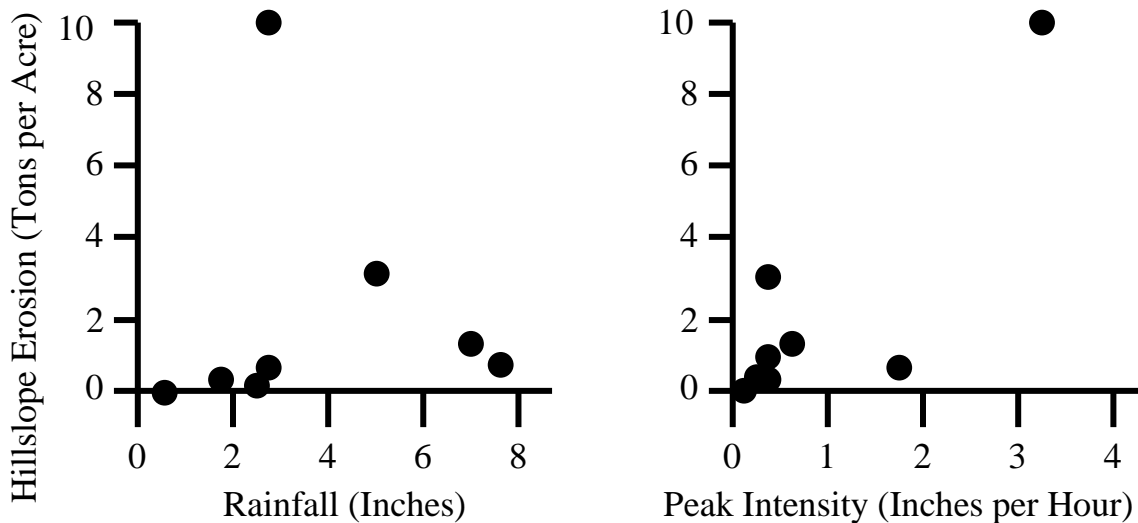
Figure 2 Rainfall-erosion relationships after the Santiago Fire.

Hillslope erosion was spatially variable over the project site. For this reason, erosion values were averaged by fence cluster rather than by treatment (Table 3). Erosion did not correlate well with rainfall amount, but there appears to be a positive linear association with peak intensity (see Figure 2), corroborating previous work (Moody and Martin 2001). However, this relationship needs to include more of the larger erosion events before it can be verified.
