STREAM NOTES

January 2008

Post-fire Erosion and the Effectiveness of Emergency Rehabilitation Treatments over Time

by Lee H. MacDonald and Peter R. Robichaud

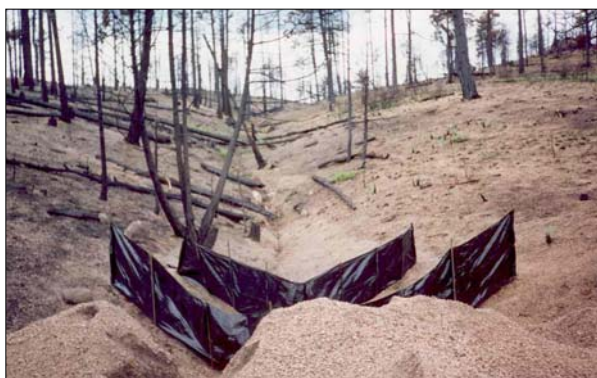
Figure 1. Photo from summer 2003 showing a pair of sediment fences, the piles of sediment excavated from the fences, and the relatively bare hillslopes after the June 2002 Hayman fire.

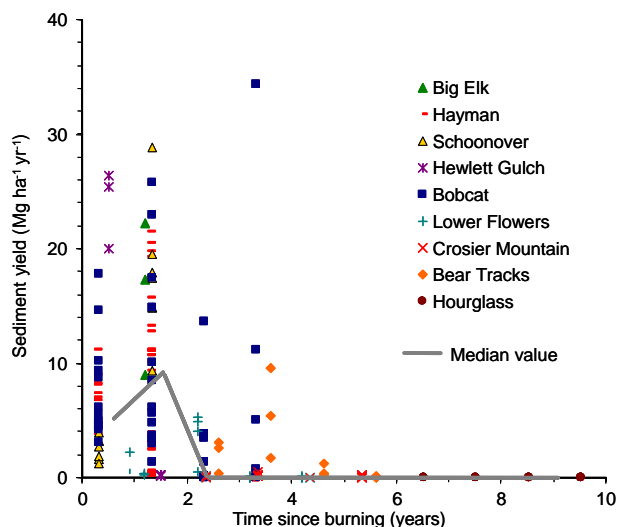
Figure 2. Annual sediment yields versus time since burning for plots at six wildfires burned at high severity and three prescribed fires in the Colorado Front Range.

Sediment production rates from sites burned at high-severity generally approach background rates by the third summer or roughly 24 months after burning (fig. 2) (Benavides-Solorio and

MacDonald, 2005; Pietraszek, 2006). Median sediment production rates are highest in the second summer after burning because summer rainfall is typically very low in the summer of burning. By the third or fourth summer after burning the median sediment production rate usually drops to near-background levels, but very high values can still occur as a result of severe storm events or those sites with particularly poor growing conditions. The range of values shows the extreme spatial and temporal variability, particularly in the first three years after burning. It is important to note that some of this variability cannot be readily explained by the observed differences in rainfall, ground cover, slope, or other site conditions.

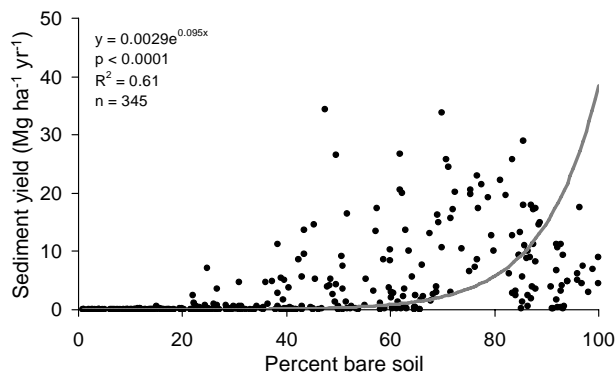
Figure 3. Relationship between percent bare soil and annual sediment yield. Data were collected from seven wildfires and three prescribed fires in the Colorado Front Range.

The large dataset collected under this and our other projects allowed us to evaluate the importance of different site characteristics on post-fire sediment production rates from both untreated and treated areas. The most significant finding is that post-fire sediment yields at the hillslope scale are most closely related to percent bare soil (fig. 3). The combined dataset shows that post-fire erosion rates are generally very low if there is less than 35-40% bare soil, highly variable when there is between 35 and 60% bare soil, and almost always high when there is more than 65% bare soil (Pietraszek, 2006). Rainfall simulation experiments indicate that percent ground cover is critical because this prevents the development of a structural seal at the soil surface that can greatly reduce infiltration rates. The ash cover present after a fire provides only a limited and very short-term protection against soil sealing. Surprisingly, removing the ground cover from an unburned site causes a similar erosion response as a high-severity wildfire (Larsen et al., in review).

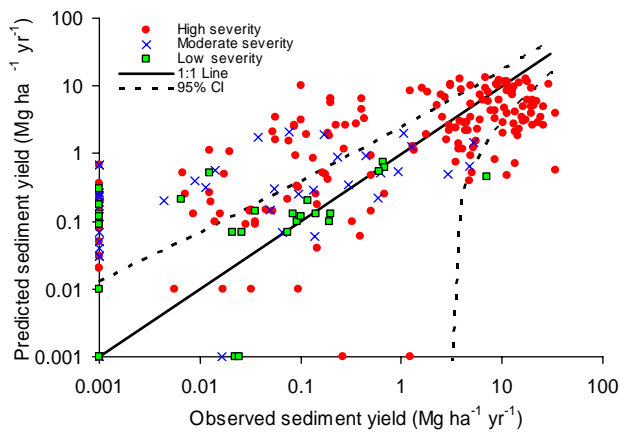
Figure 4. Mean of the predicted sediment yields using Disturbed WEPP for individual hillslopes.

sediment yields and underpredict high sediment yields (fig. 4). Neither RUSLE nor Disturbed WEPP were able to accurately predict post-fire sediment yields for individual hillslopes because of the high variability between sites and the inability to accurately represent all of the site characteristics that affect sediment yields. RUSLE and Disturbed WEPP were much more successful at predicting average sediment yields for a given fire and fire severity (Larsen and MacDonald, 2007).

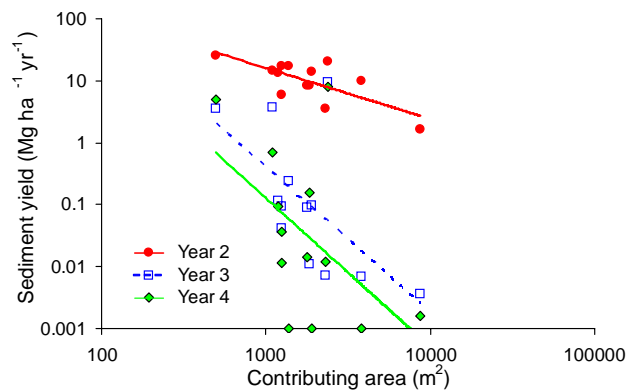
Figure 5. Sediment yield versus contributing area for convergent hillslopes, Bobcat wildfire.

The large dataset collected under this and our other projects is allowing us to determine whether sediment yields at the small plot or hillslope scale can be extrapolated to the small watershed scale. For the first two or three years after burning sediment yields for areas burned at high severity are relatively constant per unit area, but decline sharply with increasing area as burned areas recover (fig. 5) (Larsen et al., in prep.-b). Rainfall

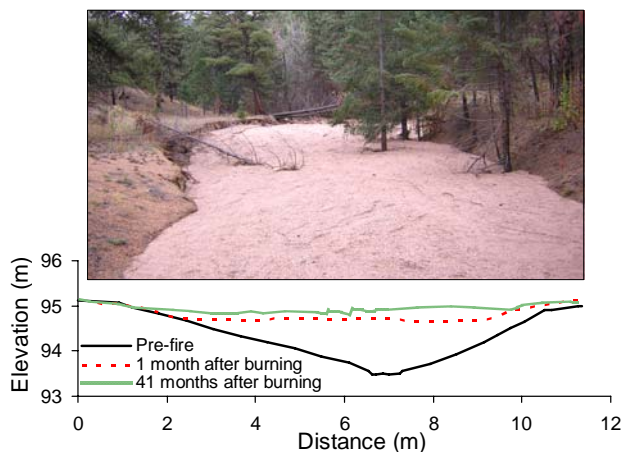
Figure 6. Post-fire sediment deposition and channel changes over time along a lower gradient channel segment; Saloon Gulch, Hayman wildfire.

The high runoff and erosion rates in headwater areas deliver large amounts of sediment to downstream channels. The predominant role of summer thunderstorms in the Colorado Front Range means that unit area peak flows decline rapidly with increasing scale. The decrease in unit area peak flows and the decline in gradient with distance downstream causes large accumulations of post-fire sediment in the lower gradient, downstream channels (fig. 6). Since hillslope runoff rates decline to near-background levels within 2-5 years, there is a rapid decline in peak flows and the corresponding ability of downstream channels to entrain and transport the accumulated sediment. This means that decades or even centuries may be necessary before the aggraded channels can recover to pre-fire conditions (Moody and Martin, 2001; Eccleston, in prep.). In some cases the aggraded sediment causes the streamflow to be primarily subsurface, and in these channels the recovery to pre-fire conditions may be extremely slow (Eccleston, in prep.).
